Simple Imaging Technique for Fitting a Below the Knee First-Time Prosthesis

Key words: below-knee prosthesis, imaging technique, malalignment

IMAJ 2004;6:713-714

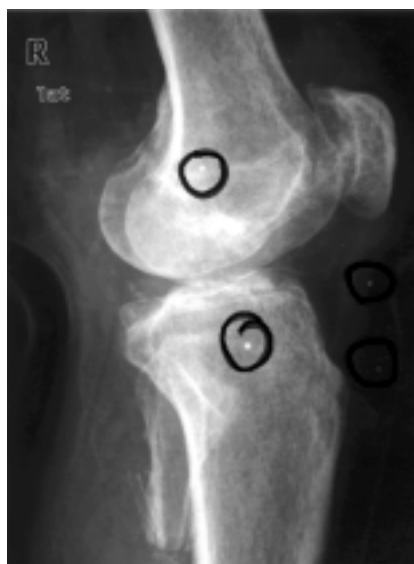
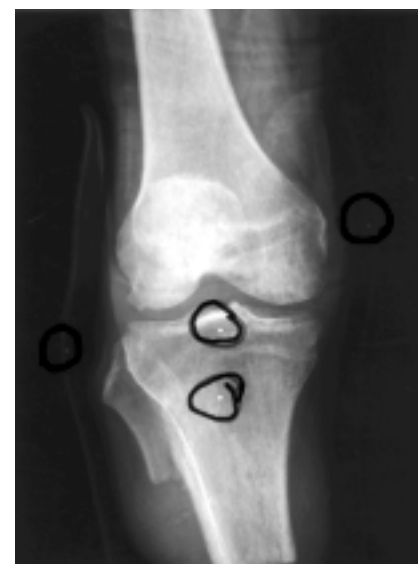
Figure 1. Good alignment of prosthesis; the weight-bearing points in the socket correspond to those of the stump.

imaging that permits us to evaluate the adaptation of the stump to the socket. Four small stickers with a metal radio-opaque point in the center are attached to the weight-bearing points around the internal socket of the prosthesis. These points are the internal and external femoral condyle, the tibial tuberosity and the patellar tendon. The patients were asked to don the prosthesis, and the X-rays – anteroposterior and lateral views – were performed in full weight bearing

strated good alignment of the weight-bearing points in the stump to those in the socket [Figure 1]. A 68 year old man with a left leg below-knee amputation exhibited skin breakdown at the edge of the stump [Figure 2] one day after the prosthesis was fitted. Plain X-

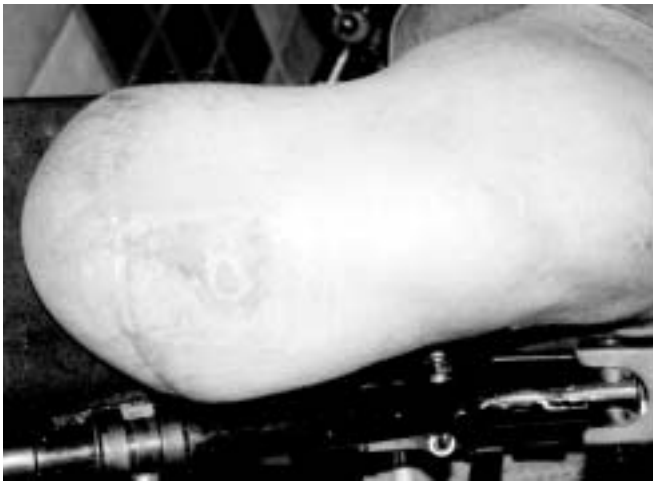
Figure 2. Skin breakdown in the stump several days after fitting of prosthesis and gait training.

strated good alignment of the weight-bearing points in the stump to those in the socket [Figure 1]. A 68 year old man with a left leg below-knee amputation exhibited skin breakdown at the edge of the stump [Figure 2] one day after the prosthesis was fitted. Plain X-

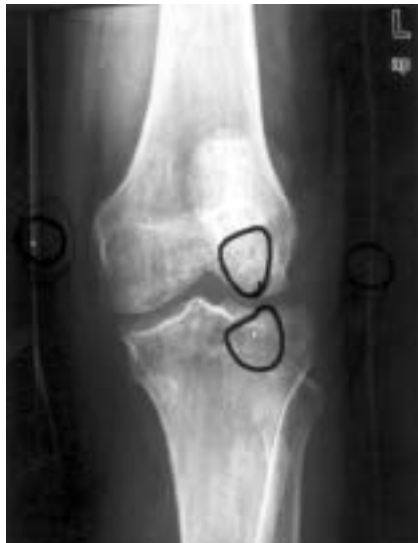
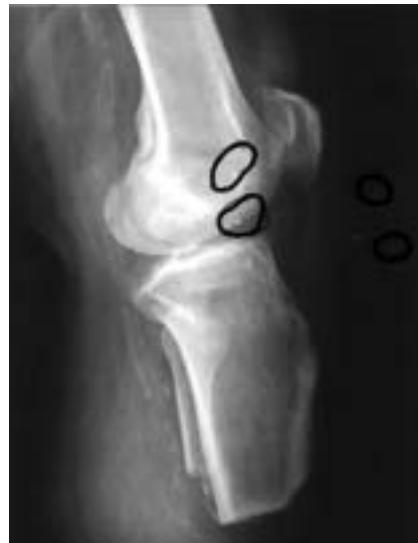
Figure 3. Malalignment of prosthesis; the weight-bearing points in the socket do not correspond to those of the stump.

to the socket did not overlap the weight-bearing points of the stump [Figure 3], indicating that the prosthesis was most probably malaligned.
